MATERIALS RESEARCH FOR THE CLEAN UTILIZATION OF COAL

QUARTERLY PROGRESS REPORT

July - September 1979

Center for Materials Science
National Bureau of Standards
Washington, D.C. 20234

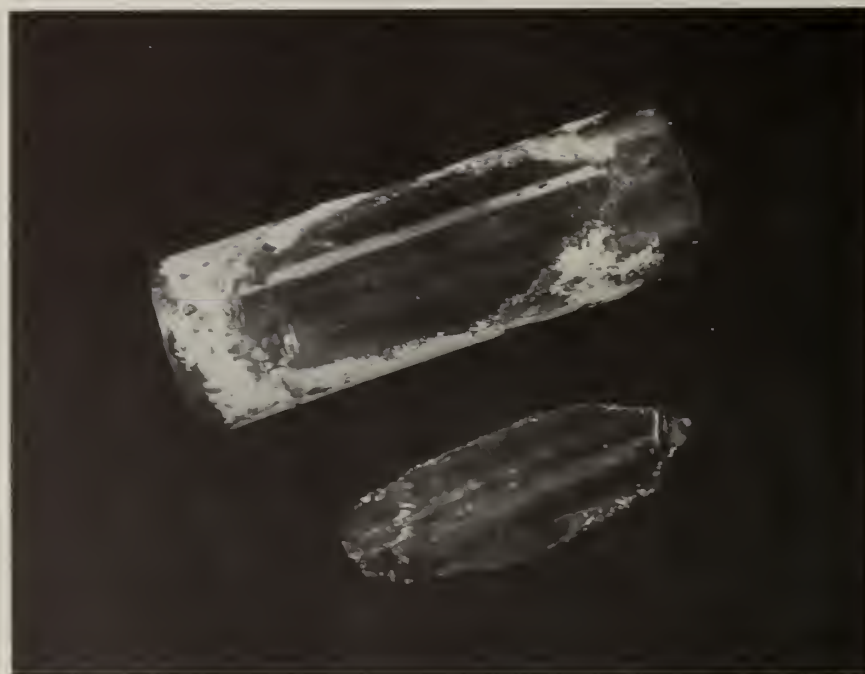
Figure 1. Burn out pattern of the platinum heater.

In experiment four, a new batch of material previously heated as described above was placed in the viscometer for viscosity measurements. The platinum heater was controlling properly at 1420°C but burned out prior to the introduction of the viscosity measuring bob. From figure 1 it can be seen that the burn out pattern on the platinum cylinder is near the position where the platinum electrode fin had been welded to the heater. In the design the position of the electrodes are fixed therefore fixing the platinum fins which are clamped to the electrodes. Thus, thermal expansion is accomplished by changes in the geometry of the platinum heater cylinder. It is most likely that the platinum was "work hardened" by repeated movement caused by such geometry changes and burned out where the metal endured maximum flexing.

These massive fins were removed from the cylinder and were welded to a new cylinder of 60%Pt and 40%Rh. Two layers of insulating material were cast about the heater. The inner layer was fabricated from green cast 97 and the outer layer from VSL 50.

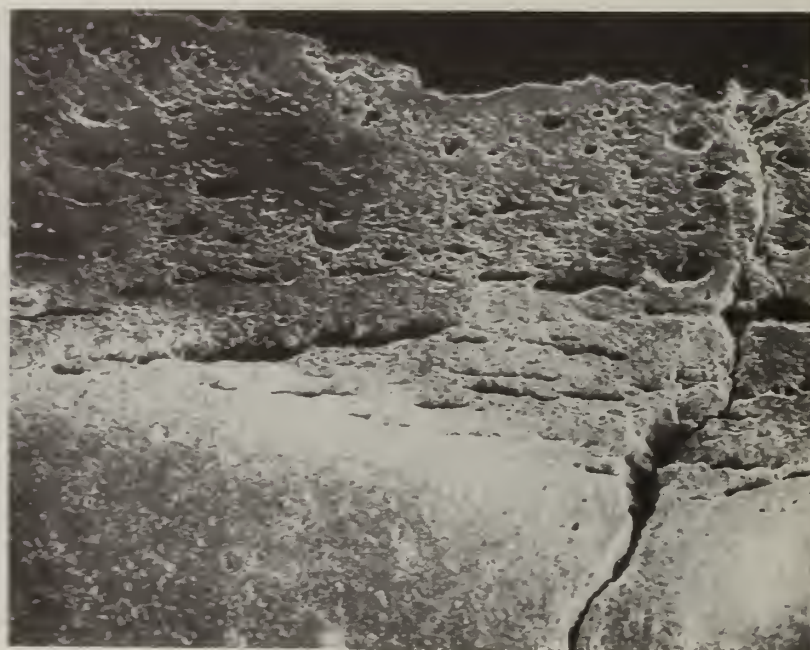
Figure 6 - Micrograph of cathode attack zone (upper half) of Bow NH slag with 20% K_2SO_4 added on $YCrO_3$ (.05 Mg). (40X)

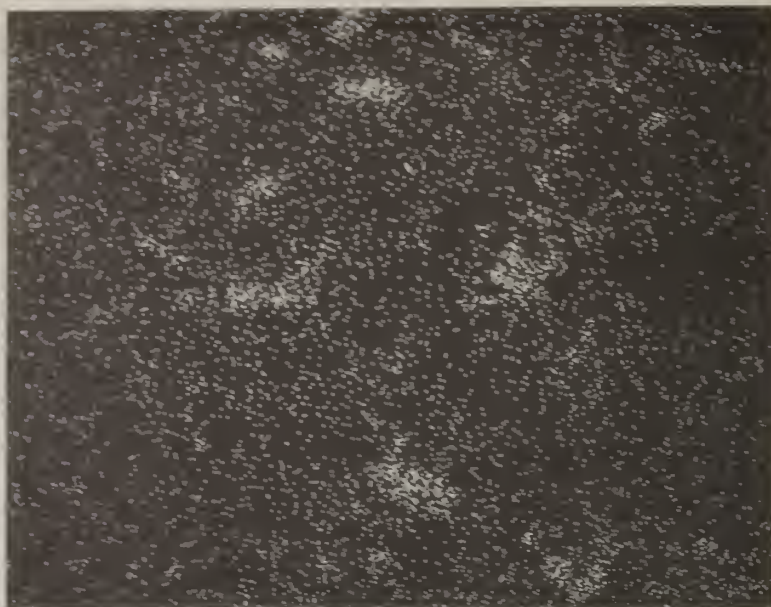
Figure 7b - Calcium x-ray map of area shown in Figure 7.

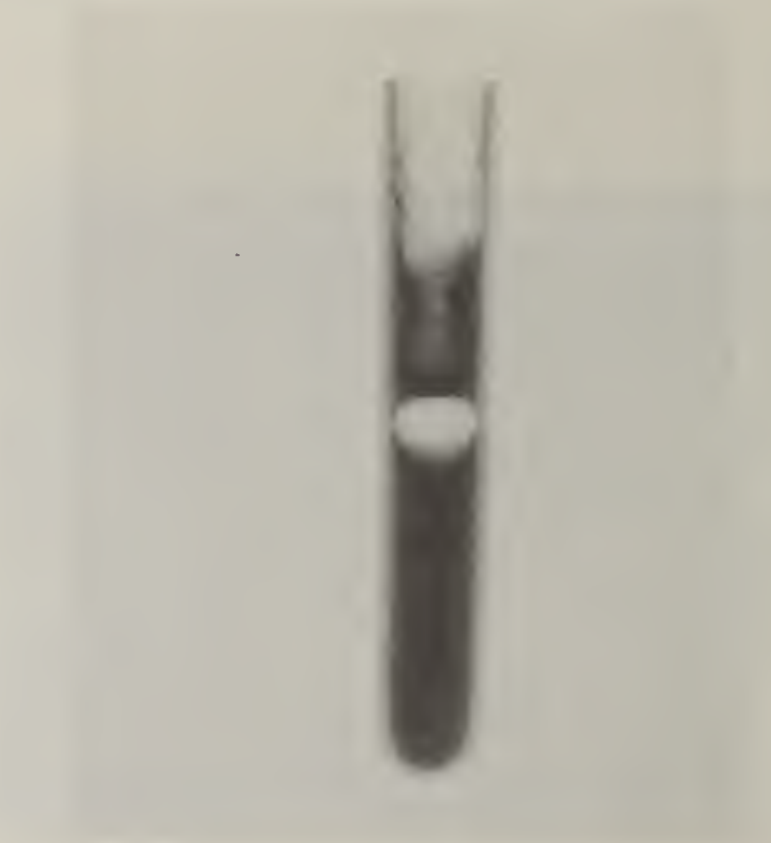
Figure 8 - Radiograph of crucible containing slag after being heated in an RF furnace to above the softening point. Note bubble formation.

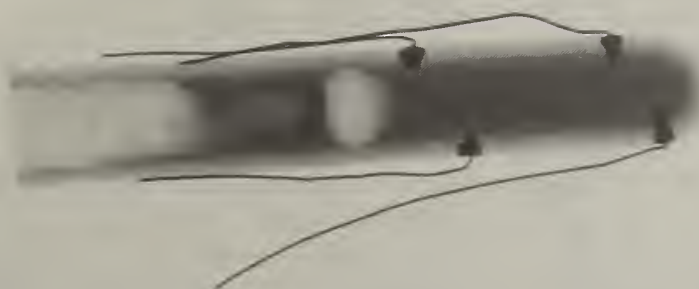
Figure 9 - Radiograph of same crucible after being contacted with platinum electrodes.

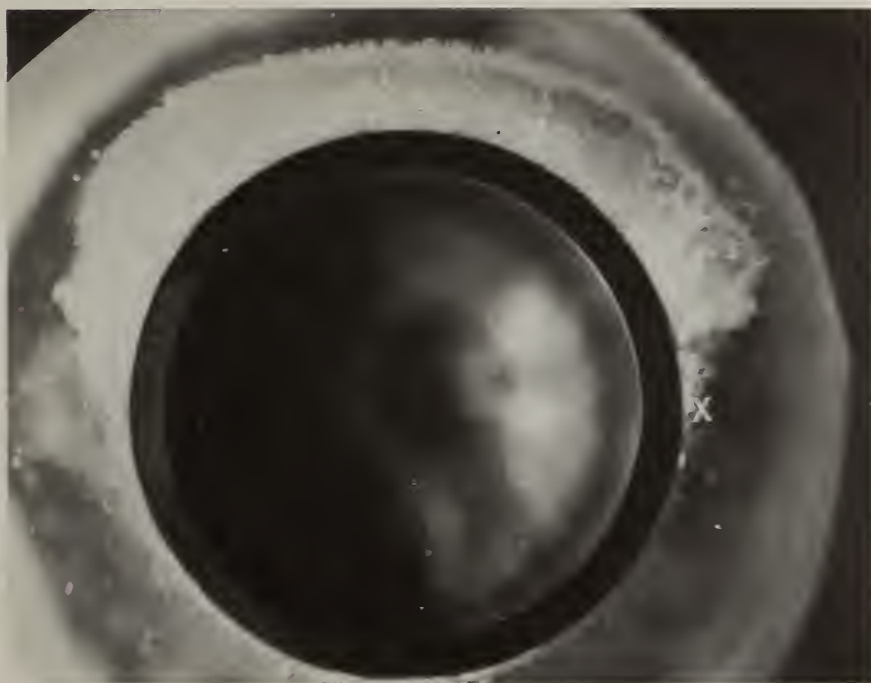
Figure 3. Section of Type 304 stainless steel tubing after exposure to K_2SO_4 seeded oxygen rich hot gas stream. Note formation of thick deposit on upper surface. Tube temperature $590^{\circ}C$. 6 X.

On each of the three Type 304 stainless steel tubes run under oxygen rich conditions a thick white, somewhat columnar deposit was formed on the upper surface of the specimens, figures 1, 2, and 3, while a thin powdery deposit formed on the remainder of the surface. The columnar deposit was approximately 2 mm thick; the powdery deposit 0.1 mm to 0.2 mm thick. SEM examination and EDX analysis of the metal-deposit interface showed what appears to be corrosion or reaction bands that increase in thickness with temperature and vary in thickness with respect to location; the thickest band being noted in the merge region of the columnar-powdery deposit at 590°C. The reaction band thicknesses range from 3 μm to 20 μm .

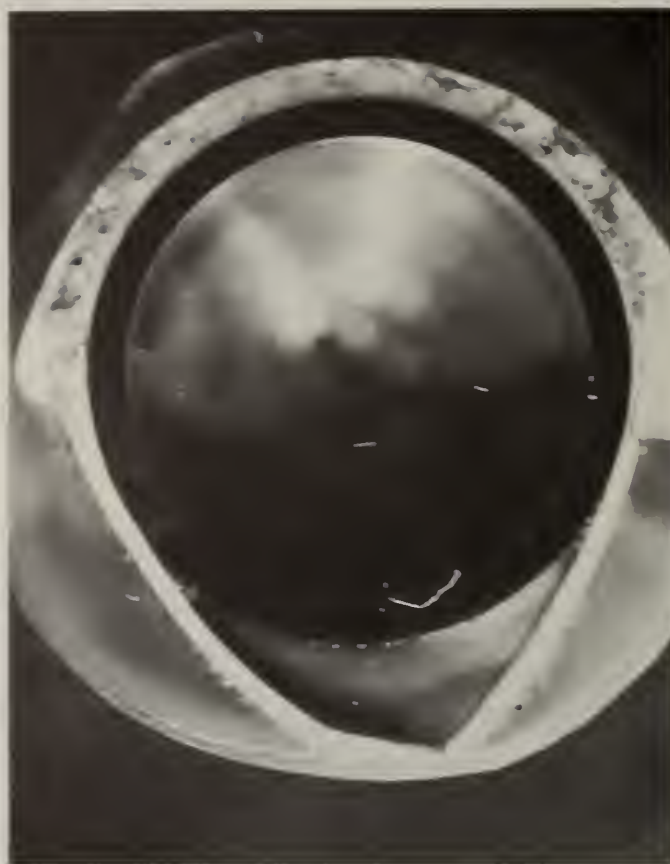
Figure 12. Section of Type 304 stainless steel tubing after exposure to K_2SO_4 seeded fuel rich hot gas stream. Note formation of thin solid deposit on upper surface. Tube temperature $400^{\circ}C$. 6 X.

Under fuel rich conditions, a thin (compared to oxygen rich conditions) less columnar type deposit formed on the upper surface of the specimens. Deposit thicknesses ranged from 0.3 mm to 0.8 mm. By contrast the powdery deposit formed on the under surface was thicker than in the oxygen rich condition, being about 0.3 mm thick, figures 12, 13, and 14. It was noted that the deposits were of a grayish cast indicating the possible presence of carbon. It was also observed that with an increase in specimen temperature the upper deposit appeared to thin, the merge region of the upper deposit with the powdery deposit appeared to descend and the powdery deposit appeared to increase in thickness. Again the metal deposit interface showed what appears to be corrosion or reaction bands that increase in reaction width with temperature and vary in thickness with location. These reaction bands range in thickness from 7 μm to perhaps 160 μm . SEM micrographs, figures 15 and 16, taken at a metal-columnar deposit interface show two distinct reaction sub-bands. EDX spectra on this region, figures 17, 18, 19, 20, 21, and 22 show high Cr peaks in the sub-band immediately adjacent to the metal-deposit interface with very little, if any, Ni present. The other sub-band shows high Fe peaks with some Ni rich zones or Cr rich zones. It should be noted that high sulfur peaks are associated with the Ni rich zones and moderate K peaks in the Fe rich zones.
